# **PORT OF DEVONPORT POST-DREDGING MARINE MONITORING REPORT**

**TasPorts**

*12 October 2026*

PROJECT REFERENCE: JN26785

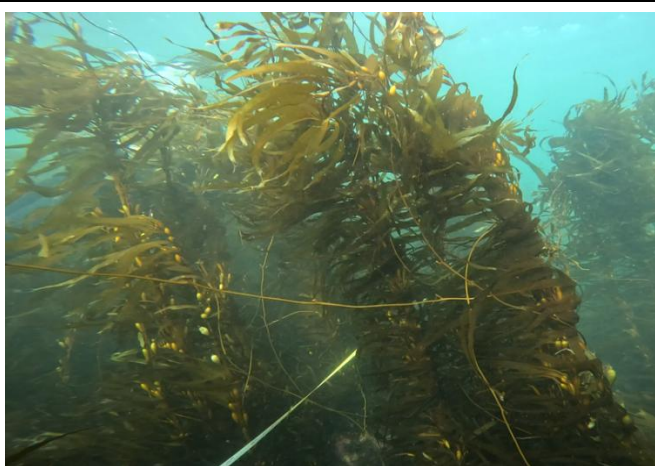
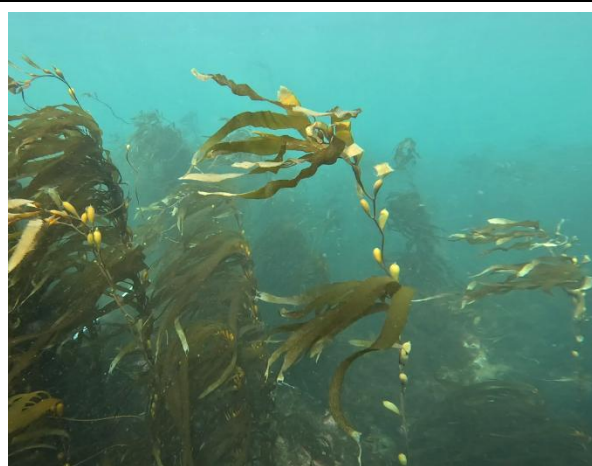
**Plate 1:** Dense kelp forest growth at the deeper offshore end of transect (left). Patchy sections of canopy were observed in the middle shallower section of the transect (right).

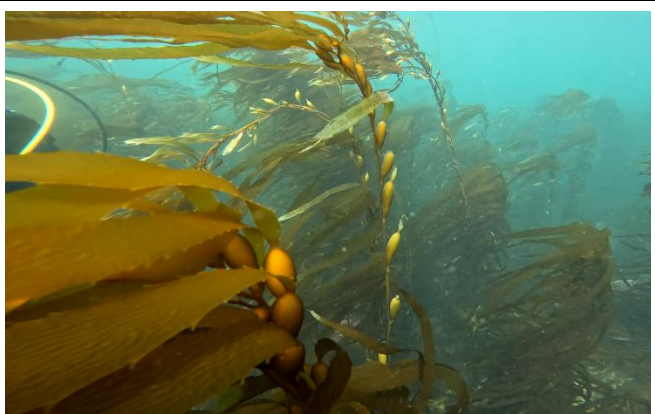
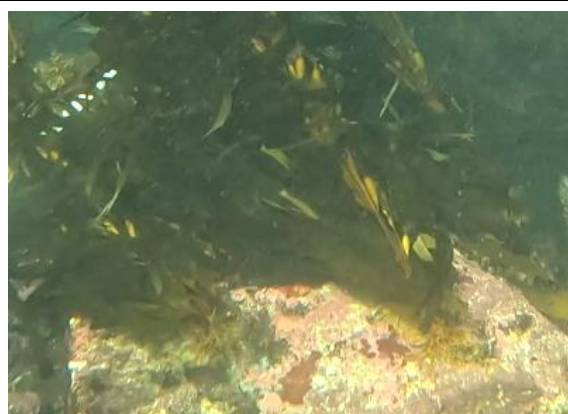
**Plate 2:** Dividing growth of kelp fronds with no epiphytic growth visible (left) and kelp holdfasts attached to boulder of the eastern break wall (right).

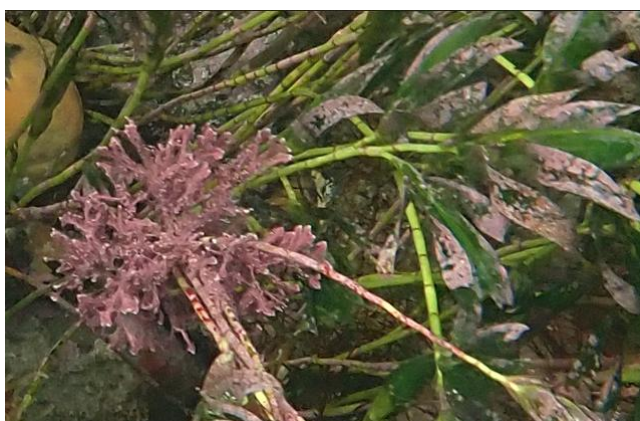
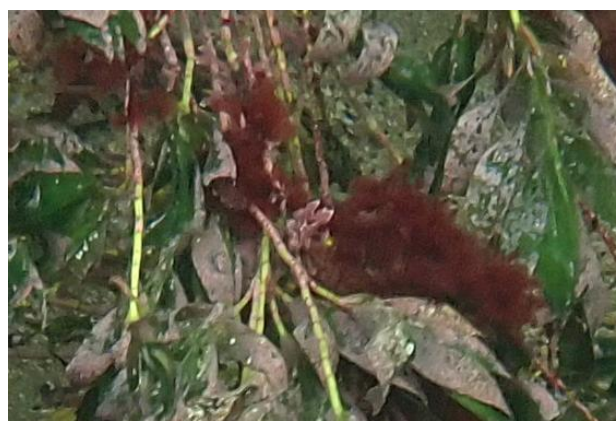
**Plate 3:** Erect coralline algae (*Corallina officinalis*) growing epiphytically on *A. antarctica* stems (left) and other non-coralline red algae species can be seen growing epiphytically on the leaves of *A. antarctica* (right). Encrusting coralline algae (as white scale) can be seen in both photos.

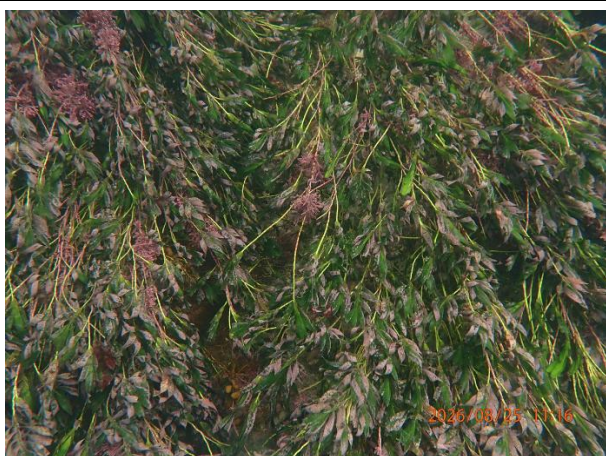
**Plate 4:** A typical Northdown quadrat with dense seagrass cover (left), and dense macroalgae (*Caulerpa flexilis*) cover (right).

Northdown had the highest mean seagrass cover of the survey locations. The site was characterised by cobble and sand substrate, densely covered in seagrass which transitioned into low-profile reef covered in macroalgae (predominantly *Caulerpa flexilis*). Epiphytic growth at this location was moderate, dominated by encrusting coralline algae on seagrass blades. Erect coralline algae and other epiphytic algal species were also observed growing on the stems of *A. antarctica*.

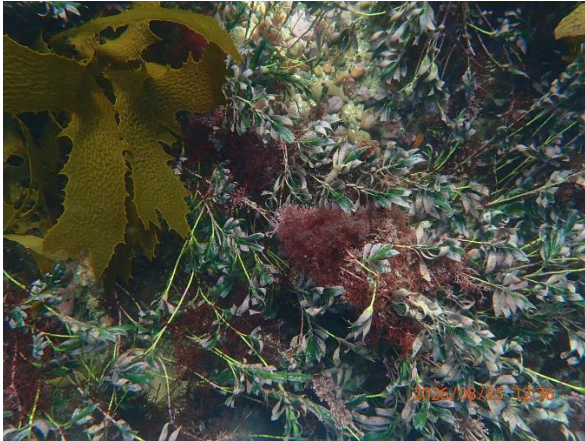
**Plate 5:** Typical Horseshoe quadrats featuring dense *A. antarctica* cover and *Ecklonia radiata* macroalgae (left) with patchy sections of sand and cobbles (right).

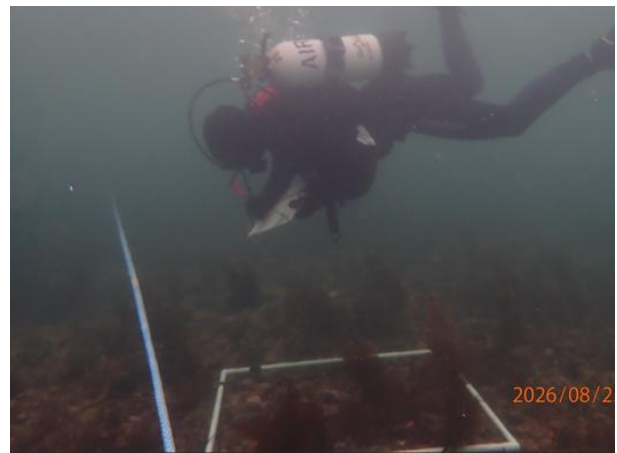
**Plate 6:** Typical Pardoe quadrats consisting of patchy coverage of both *A. antarctica* (left), and macroalgae (left and right)

Pardoe displayed substantially less seagrass cover compared to the other survey locations and the highest proportion of bare substrate (sand and cobble), with patchy seagrass and macroalgae cover. Pardoe had the lowest mean epiphyte score of the survey locations, which was dominated by encrusting coralline algae on *A. antarctica* blades.

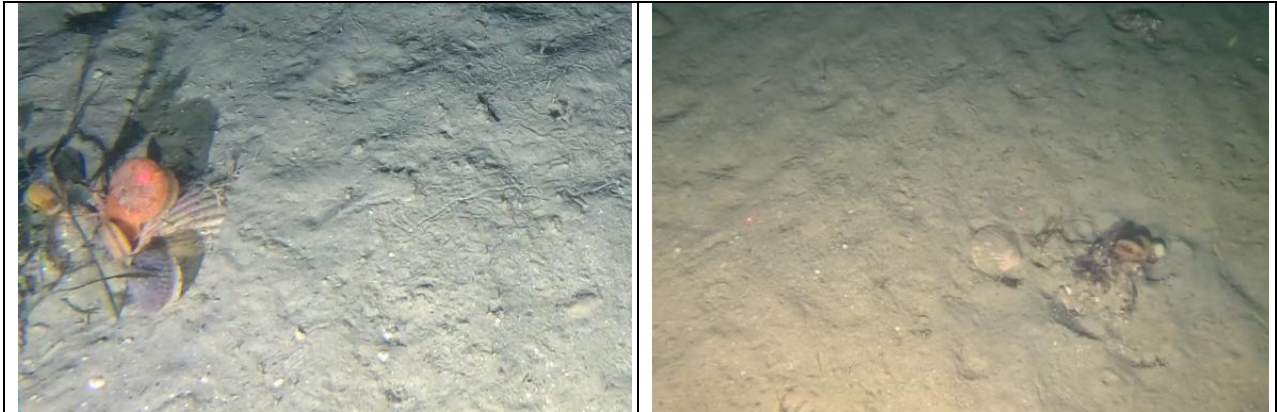
**Plate 1.** Doughboy scallops and typical fine sand and silt substrate on the East 7 transect.

The East 7 transect was recorded at 115m in 35m depth over a bottom of fine sand and silt substrate (**Plate 1**). Twenty-six scallops (19 doughboy and 7 commercials) were counted with a total scallop density of 0.3 scallops m<sup>2</sup> over an area of approximately 86 m<sup>2</sup>. Numerous collections of dead shells were noted, along with one observation of a Sand Flathead (*Platycephalus bassensis*).

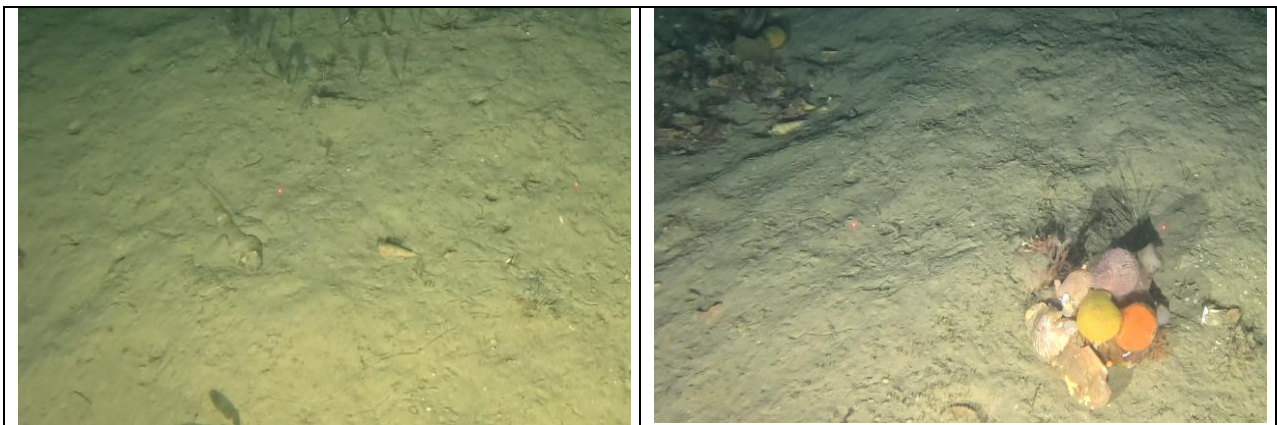
**Plate 2.** Typical bare sediment substrate, flathead (left) and doughboy scallops attached to sessile fauna (right) on East 8.

The East 8 transect was recorded at 144m in 38m depth, over a bottom of fine sand and silt (**Plate 2**). A total of 111 scallops (72 doughboy and 39 commercials) were counted at a density of 1.03 scallops per m<sup>2</sup> over an area of approximately 108 m<sup>2</sup>. Collections of dead shells were noted in this transect, along with one observation of a Sand Flathead (*Platycephalus bassensis*).

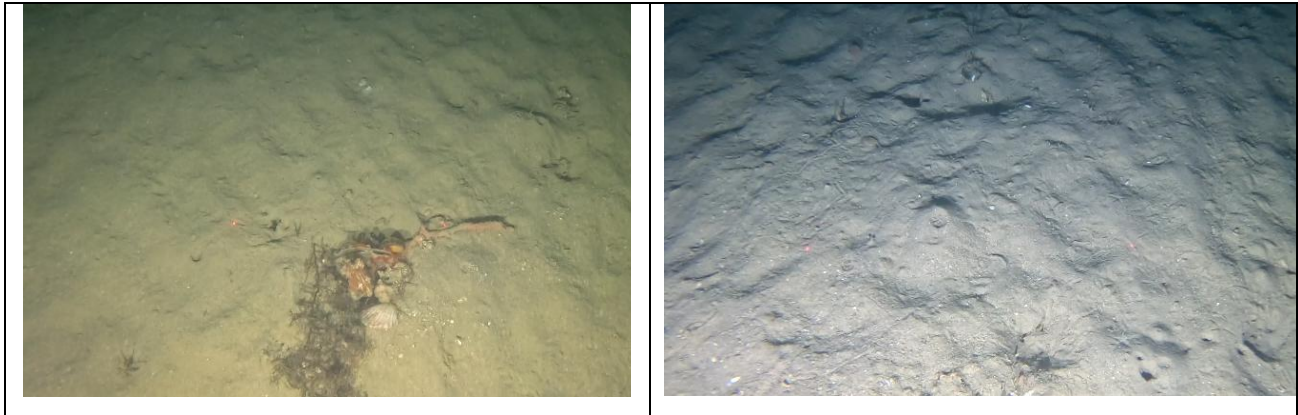
**Plate 7.** Unidentified octopus species (left) and typical bare sediment substrate on the West Edge transect (right).

Transect West Edge was recorded at 125 m in 35 m of water over fine sand substrate. Small patches of sessile fauna were also observed. 36 (28 doughboy and 8 commercials) were counted with a total scallop density of 0.4 scallops m<sup>2</sup> over an area of approximately 93 m<sup>2</sup>. Collections of dead shells were noted, along with one observation of an unidentified Octopus species (**Plate 7**).

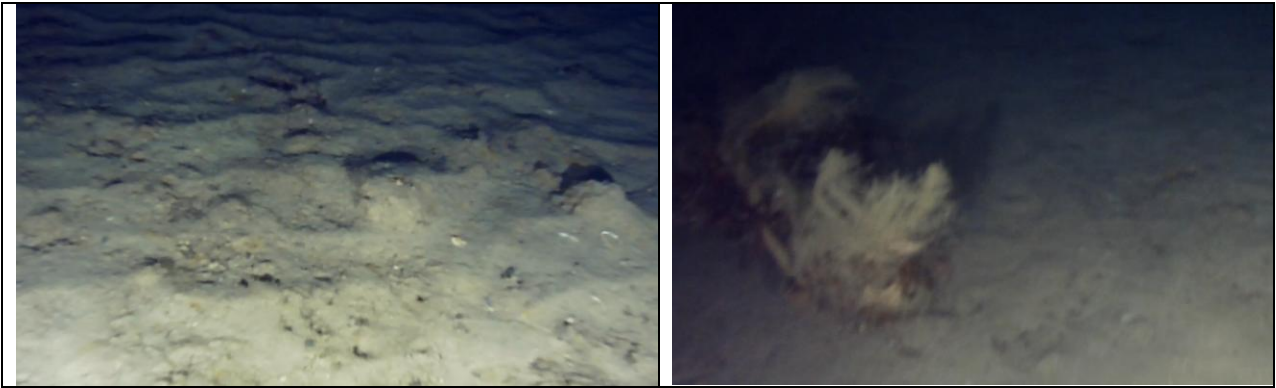
**Plate 1.** T0 – Examples of unconsolidated substrate comprising of fine sand and silt and patch of soft coral within the DSDG.

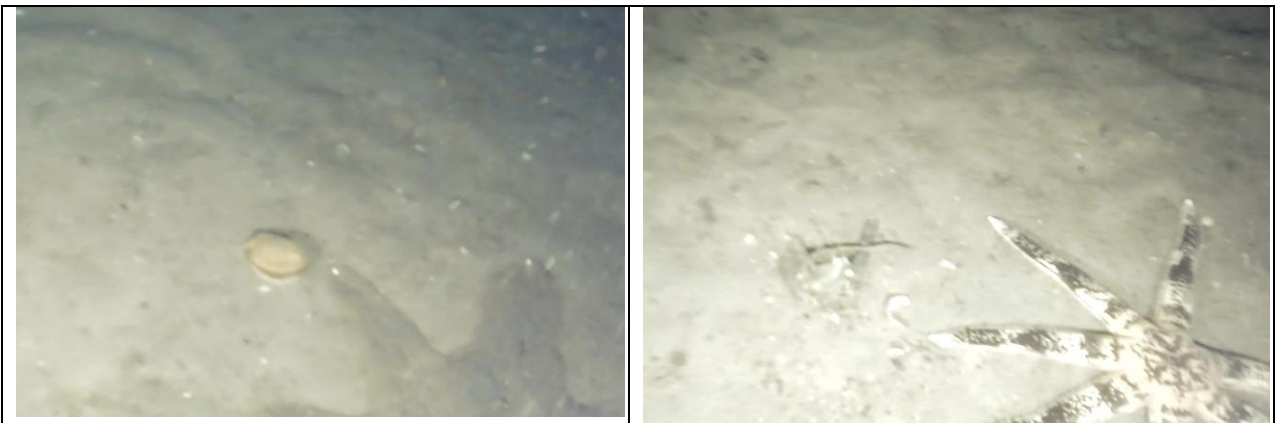
**Plate 2.** T1 – Examples of unconsolidated substrate comprising of fine sand and silt within the DSDG. Doughboy scallops and the Southern Sand Star were present.

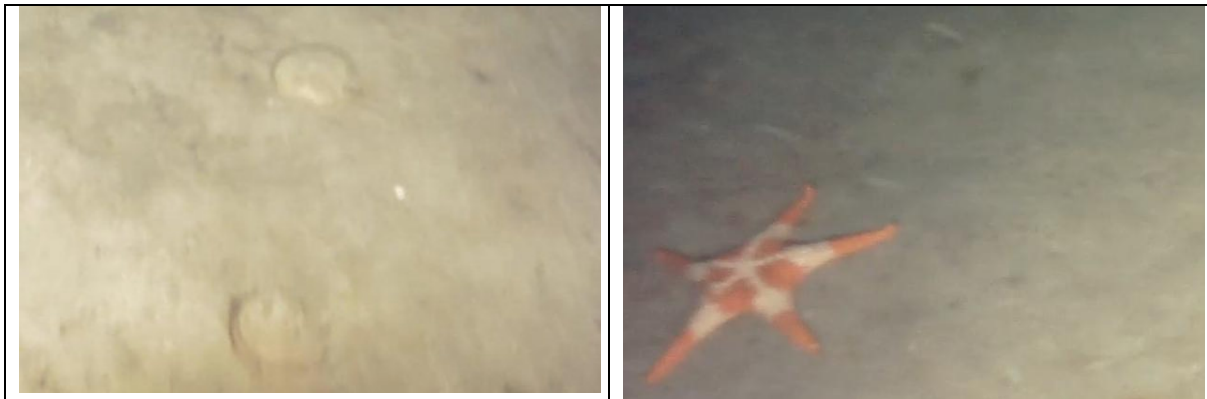
**Plate 3.** T8 – Examples of unconsolidated substrate comprising of fine sand and silt and presence of Commercial Scallops and Ocellate seastar within the DSDG.

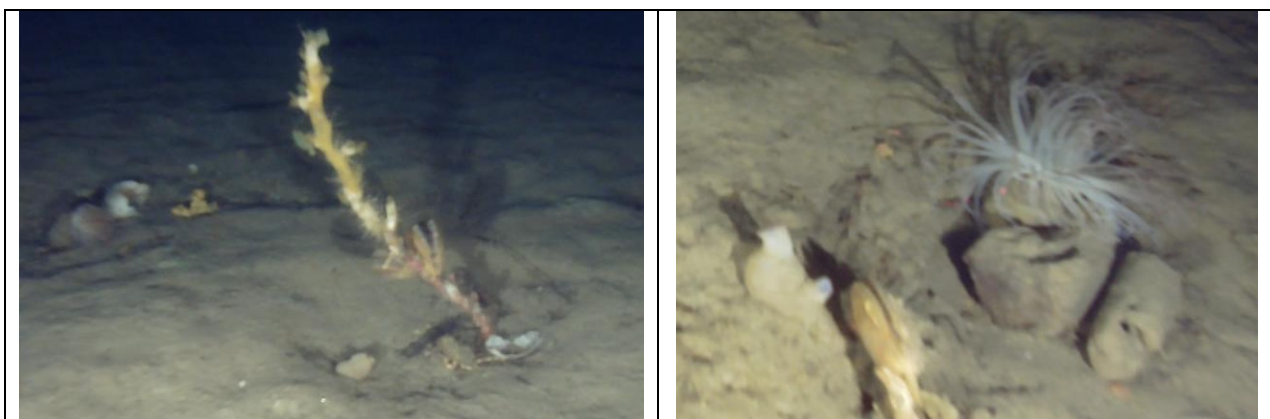
**Plate 4.** T9 – Examples of unconsolidated substrate comprising of sand and silt and presence of erected sponges (with doughboy attached) and Polychaete worms within the DSDG.

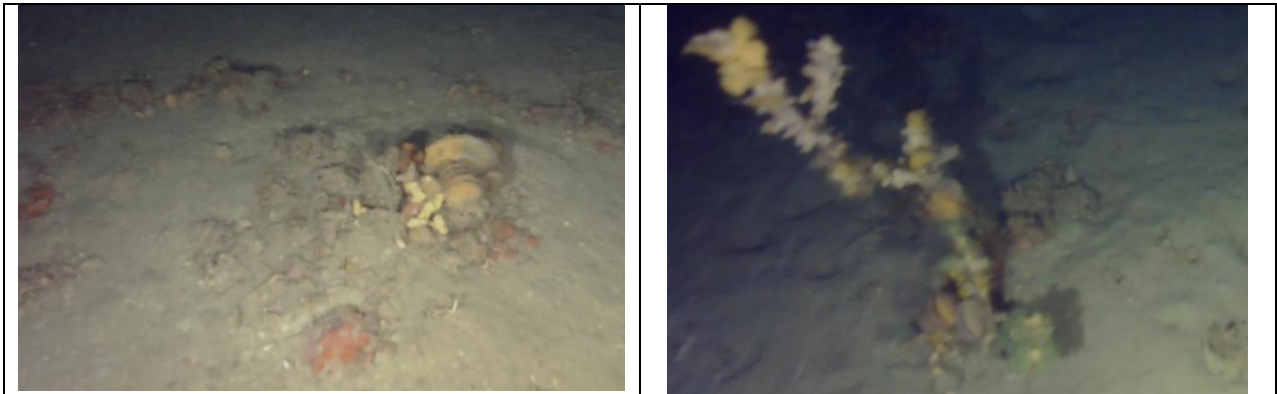
**Plate 5.** T2 – Examples of unconsolidated substrate comprising of sand and silt and low-profile reef (left) and presence of erected sponges (right) outside of the DSDG.

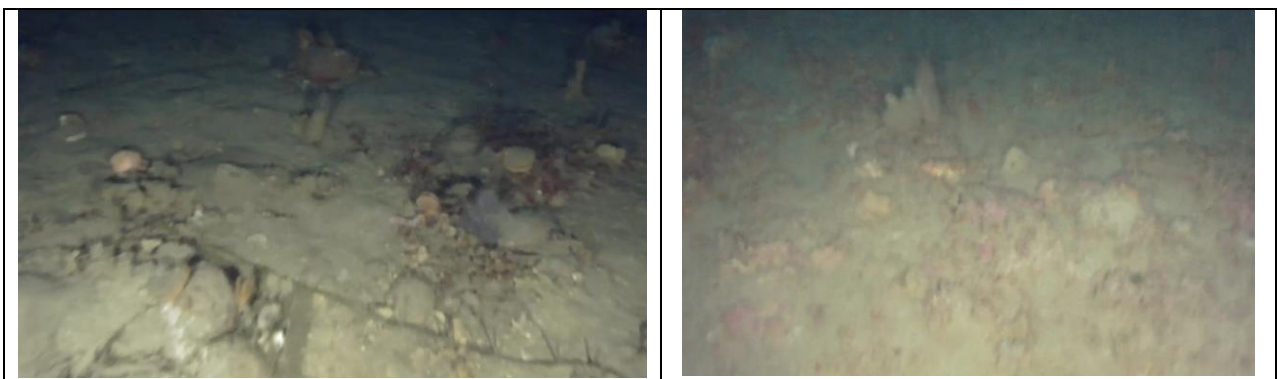
**Plate 6.** T3 – Examples of low-profile reef within interspersed with areas of fine sand and silt outside of the DSDG3.

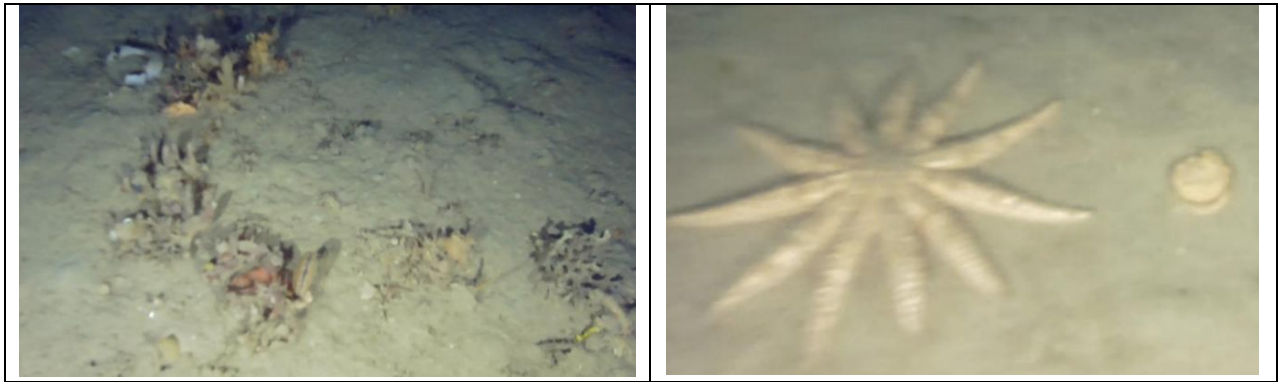
**Plate 7.** T4 – Examples of sessile benthic fauna patches, eleven-armed sea star and doughboy scallop on fine sand and silt outside of the DSDG.

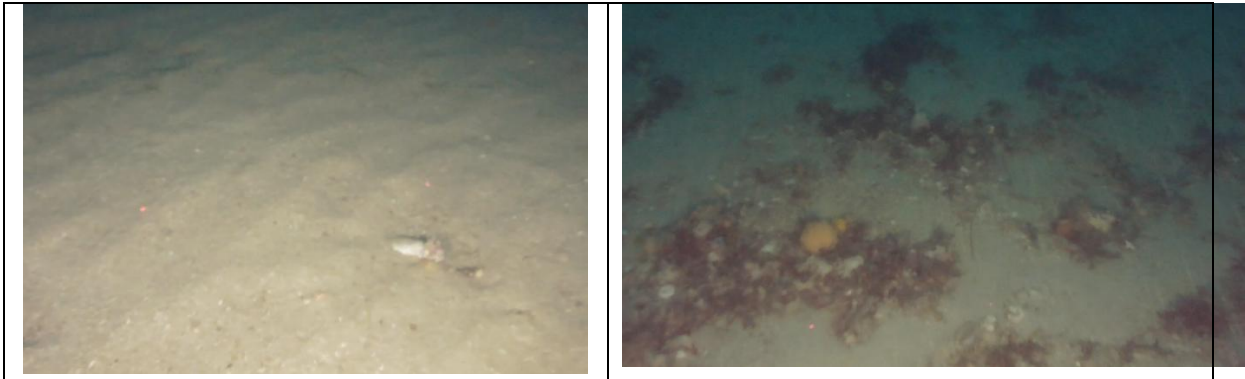
**Plate 10.** T7 – Examples of macroalgae and sponge clumps growing on fine to medium grade sand and gravel outside of the DSDG.

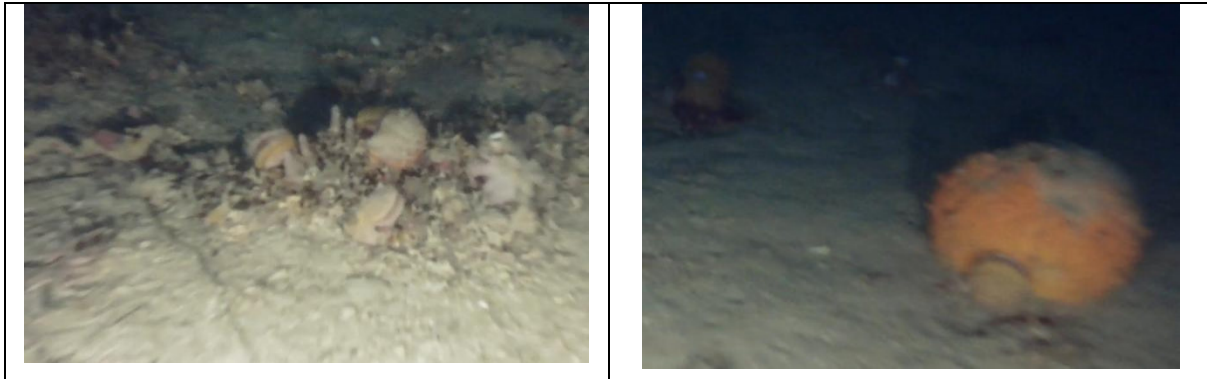
**Plate 11.** DSDG 6 – Examples of fine to medium sand substrate with doughboy scallops growing on shell grit and sponge clumps outside of the DSDG.

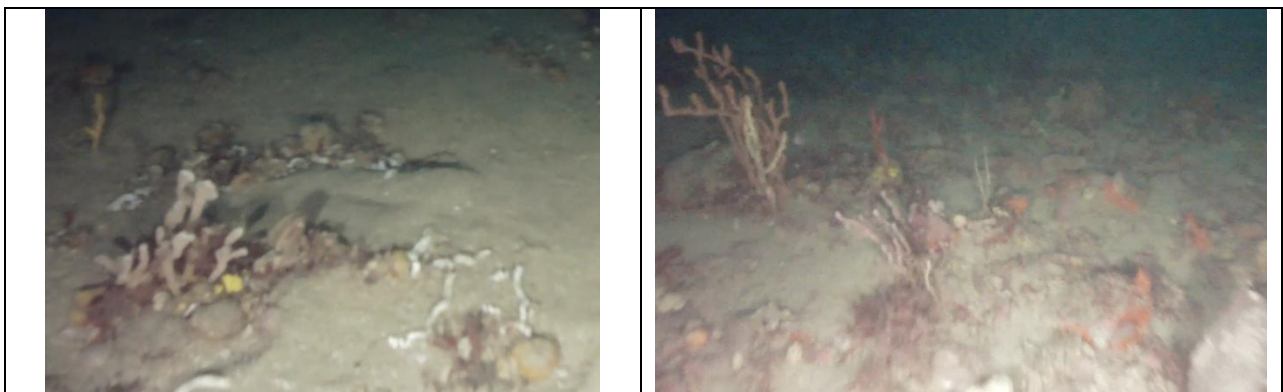
**Plate 12.** DSDG 9 –Examples of low-profile reef interspersed with areas of fine to medium sand and silt outside of the DSDG.
